**National
Transportation
Safety Board**

Lithium Batteries on Airplanes:

Is this an accident waiting to happen?

Robert Sumwalt FRAeS

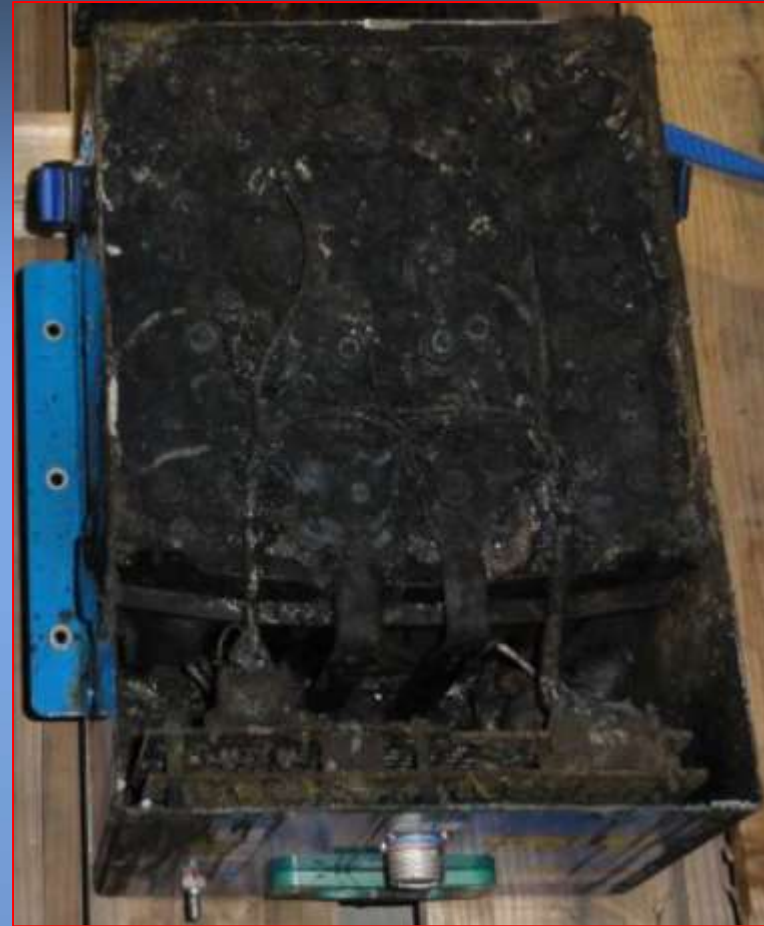
Smoke Output of 787 Battery

Video shows amount of smoke output from eight cells of battery at UL Fire Laboratory (edited)

This smoke is hazardous to breath, potentially flammable, and corrosive.

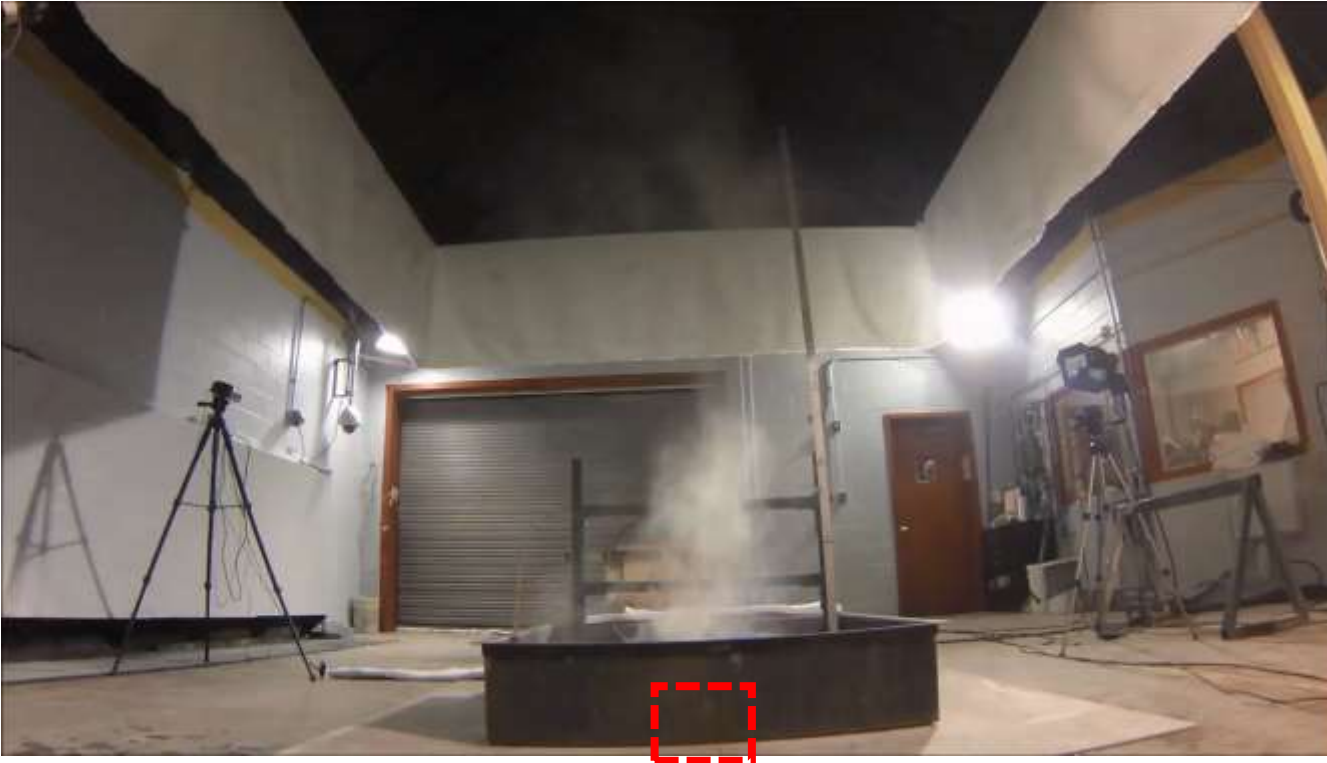
Original location and size of compartment
